Monitoring Cruise at the Saco Bay
Disposal Site, May 1990

Disposal Area Monitoring System DAMOS

Contribution 81
April 1991

US Army Corps
of Engineers
New England Division

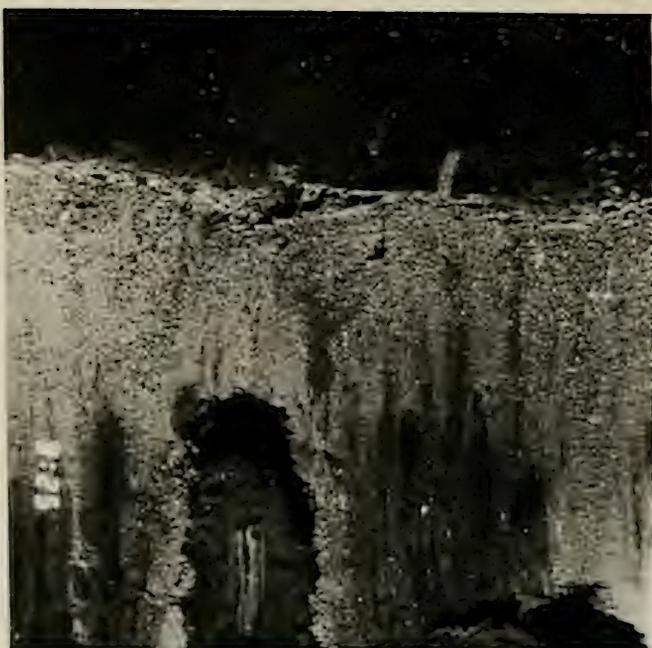
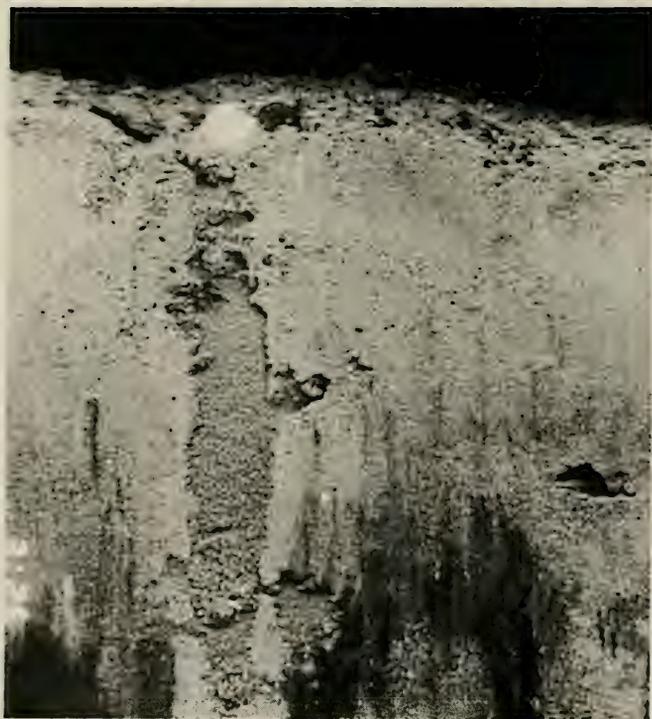
Figure 3-11. REMOTS[®] photographs of large burrows present at Saco Bay Disposal Site and reference stations, May 1990. A) Station 5. B) REF-3, Station CTR.

Infaunal successional seres in the central and southern regions of the disposal site were generally either Stage I or Stage I on III (Figure 3-10). To the north and along the eastern and western borders, Stage II and Stage II on III were the dominant seres. The reference stations consisted principally of either Stage I on III at REF-2, or Stage II and Stage II on III at REF-3. Large infaunal burrows (some as long as 9 cm) were present in REMOTS® photographs taken at both the disposal site and the reference stations (Figure 3-11).
